River dynamics, bank erosion and the fine sediment load in pearl mussel rivers

Survey of bank erosion: Pearl mussel river Schondra, Rhine catchment

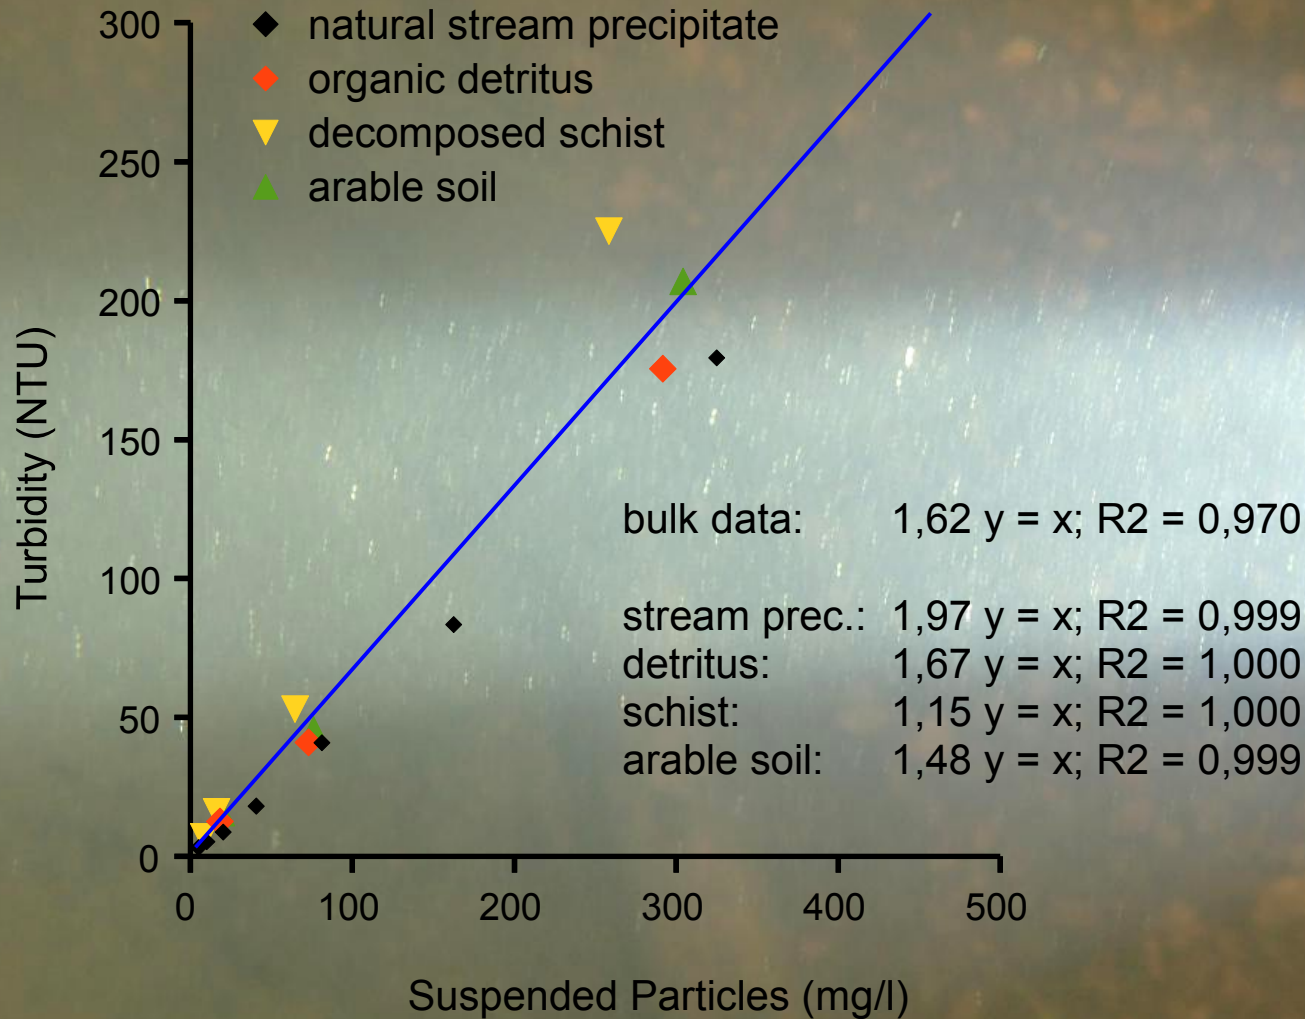
Turbidity

1 NTU \approx 1,2 - 2.0 mg / l of suspended particles

Österling et al. 2010:

0.96 ± 0.14 NTU in streams with juvenile pearl mussels

> 1.9 NTU in streams without recent pearl mussel recruitment

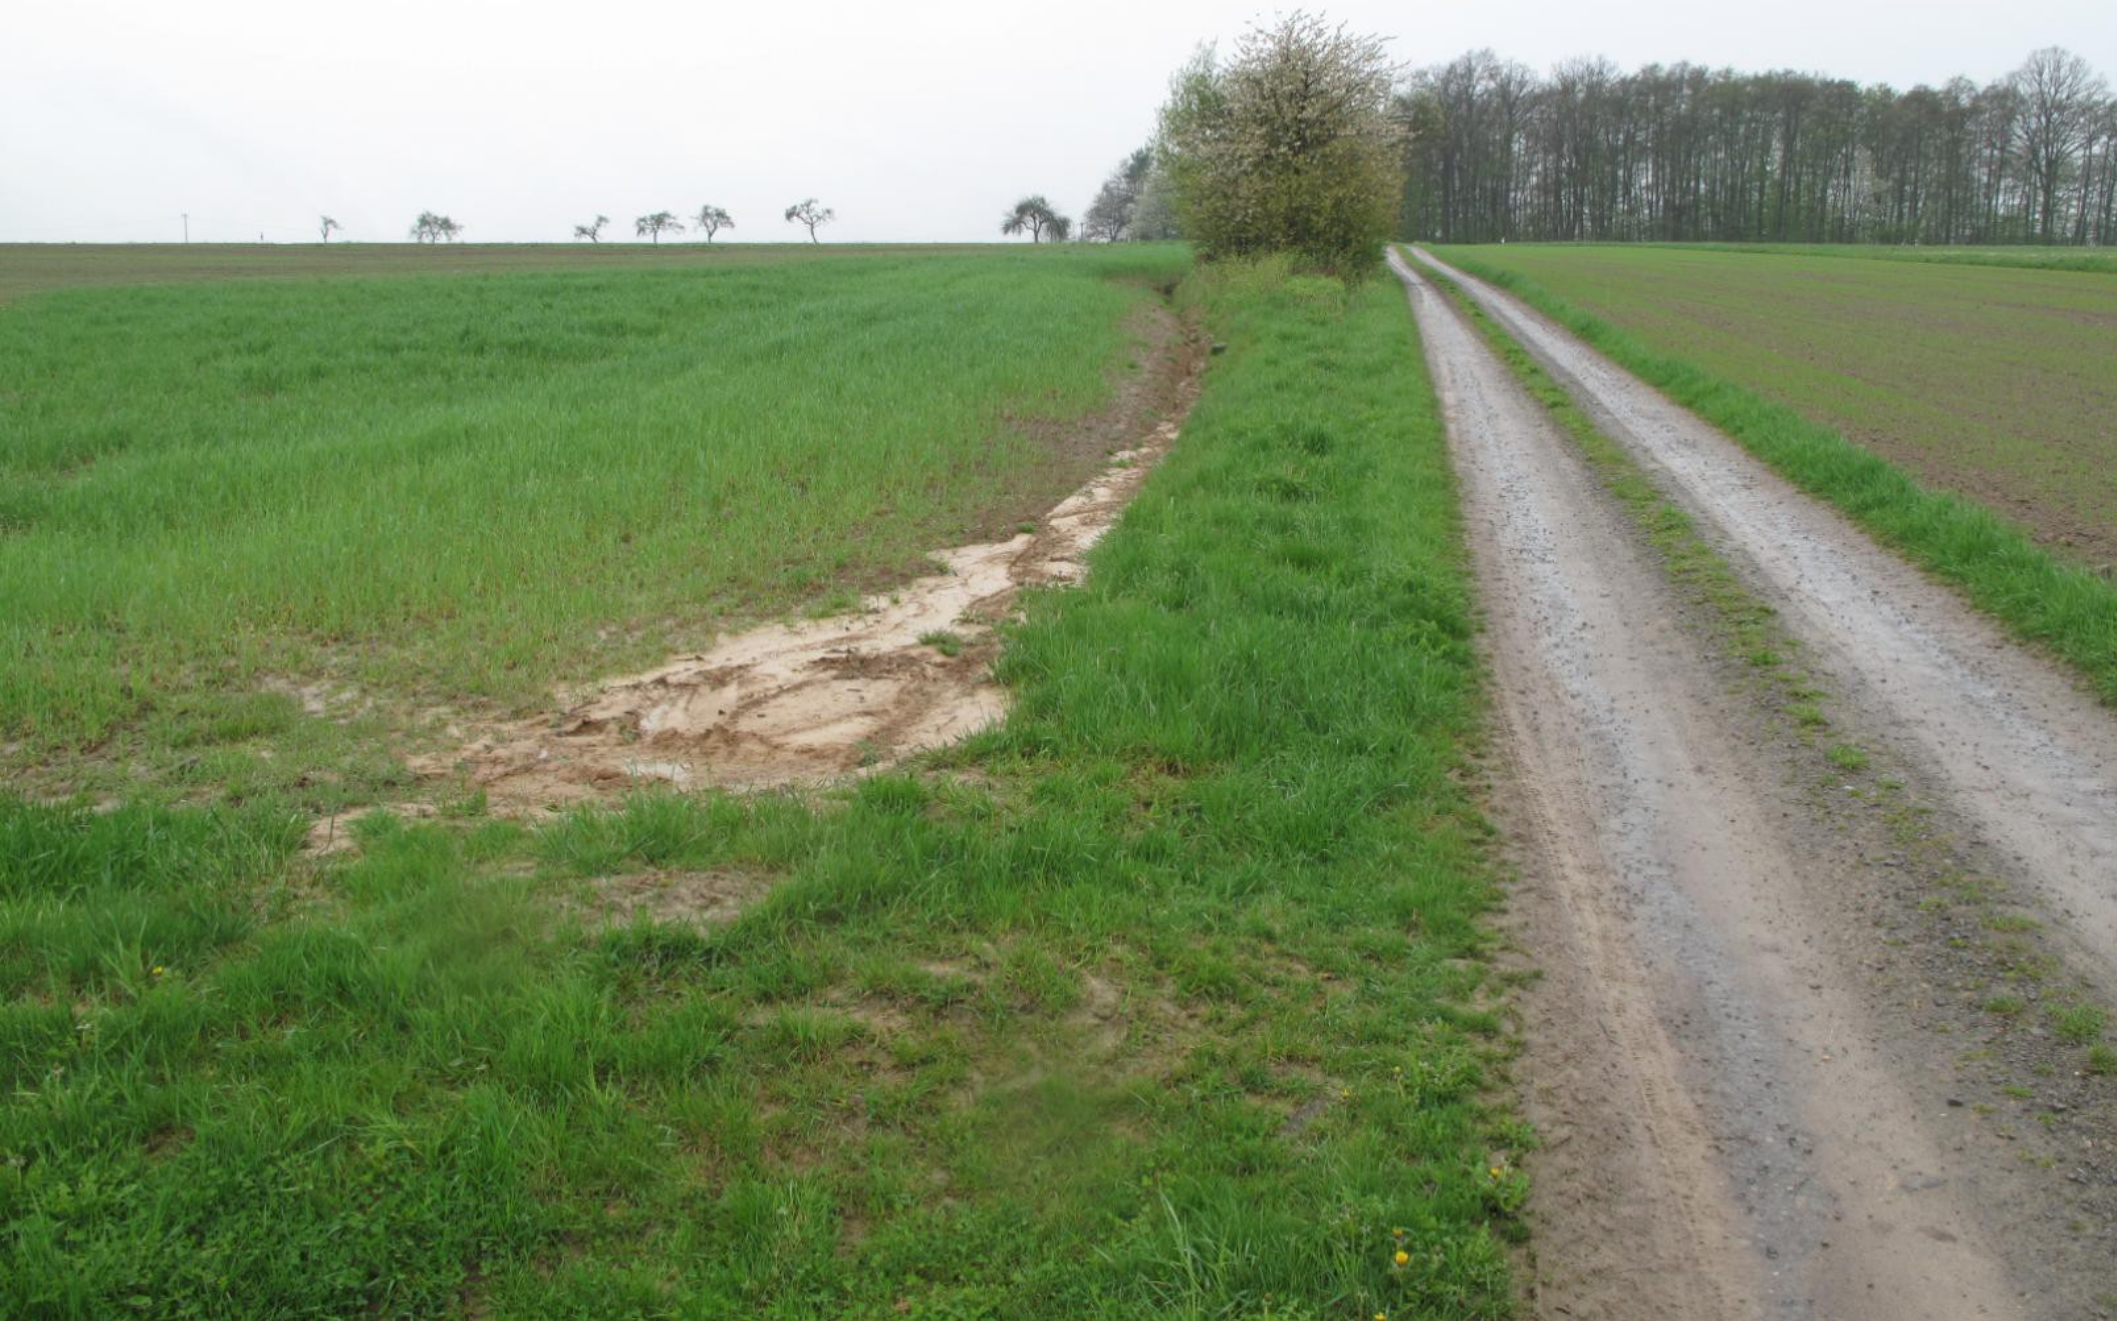
sources of silt and clay: soil erosion from arable fields

ditches facilitate the transport of eroded soil to the river

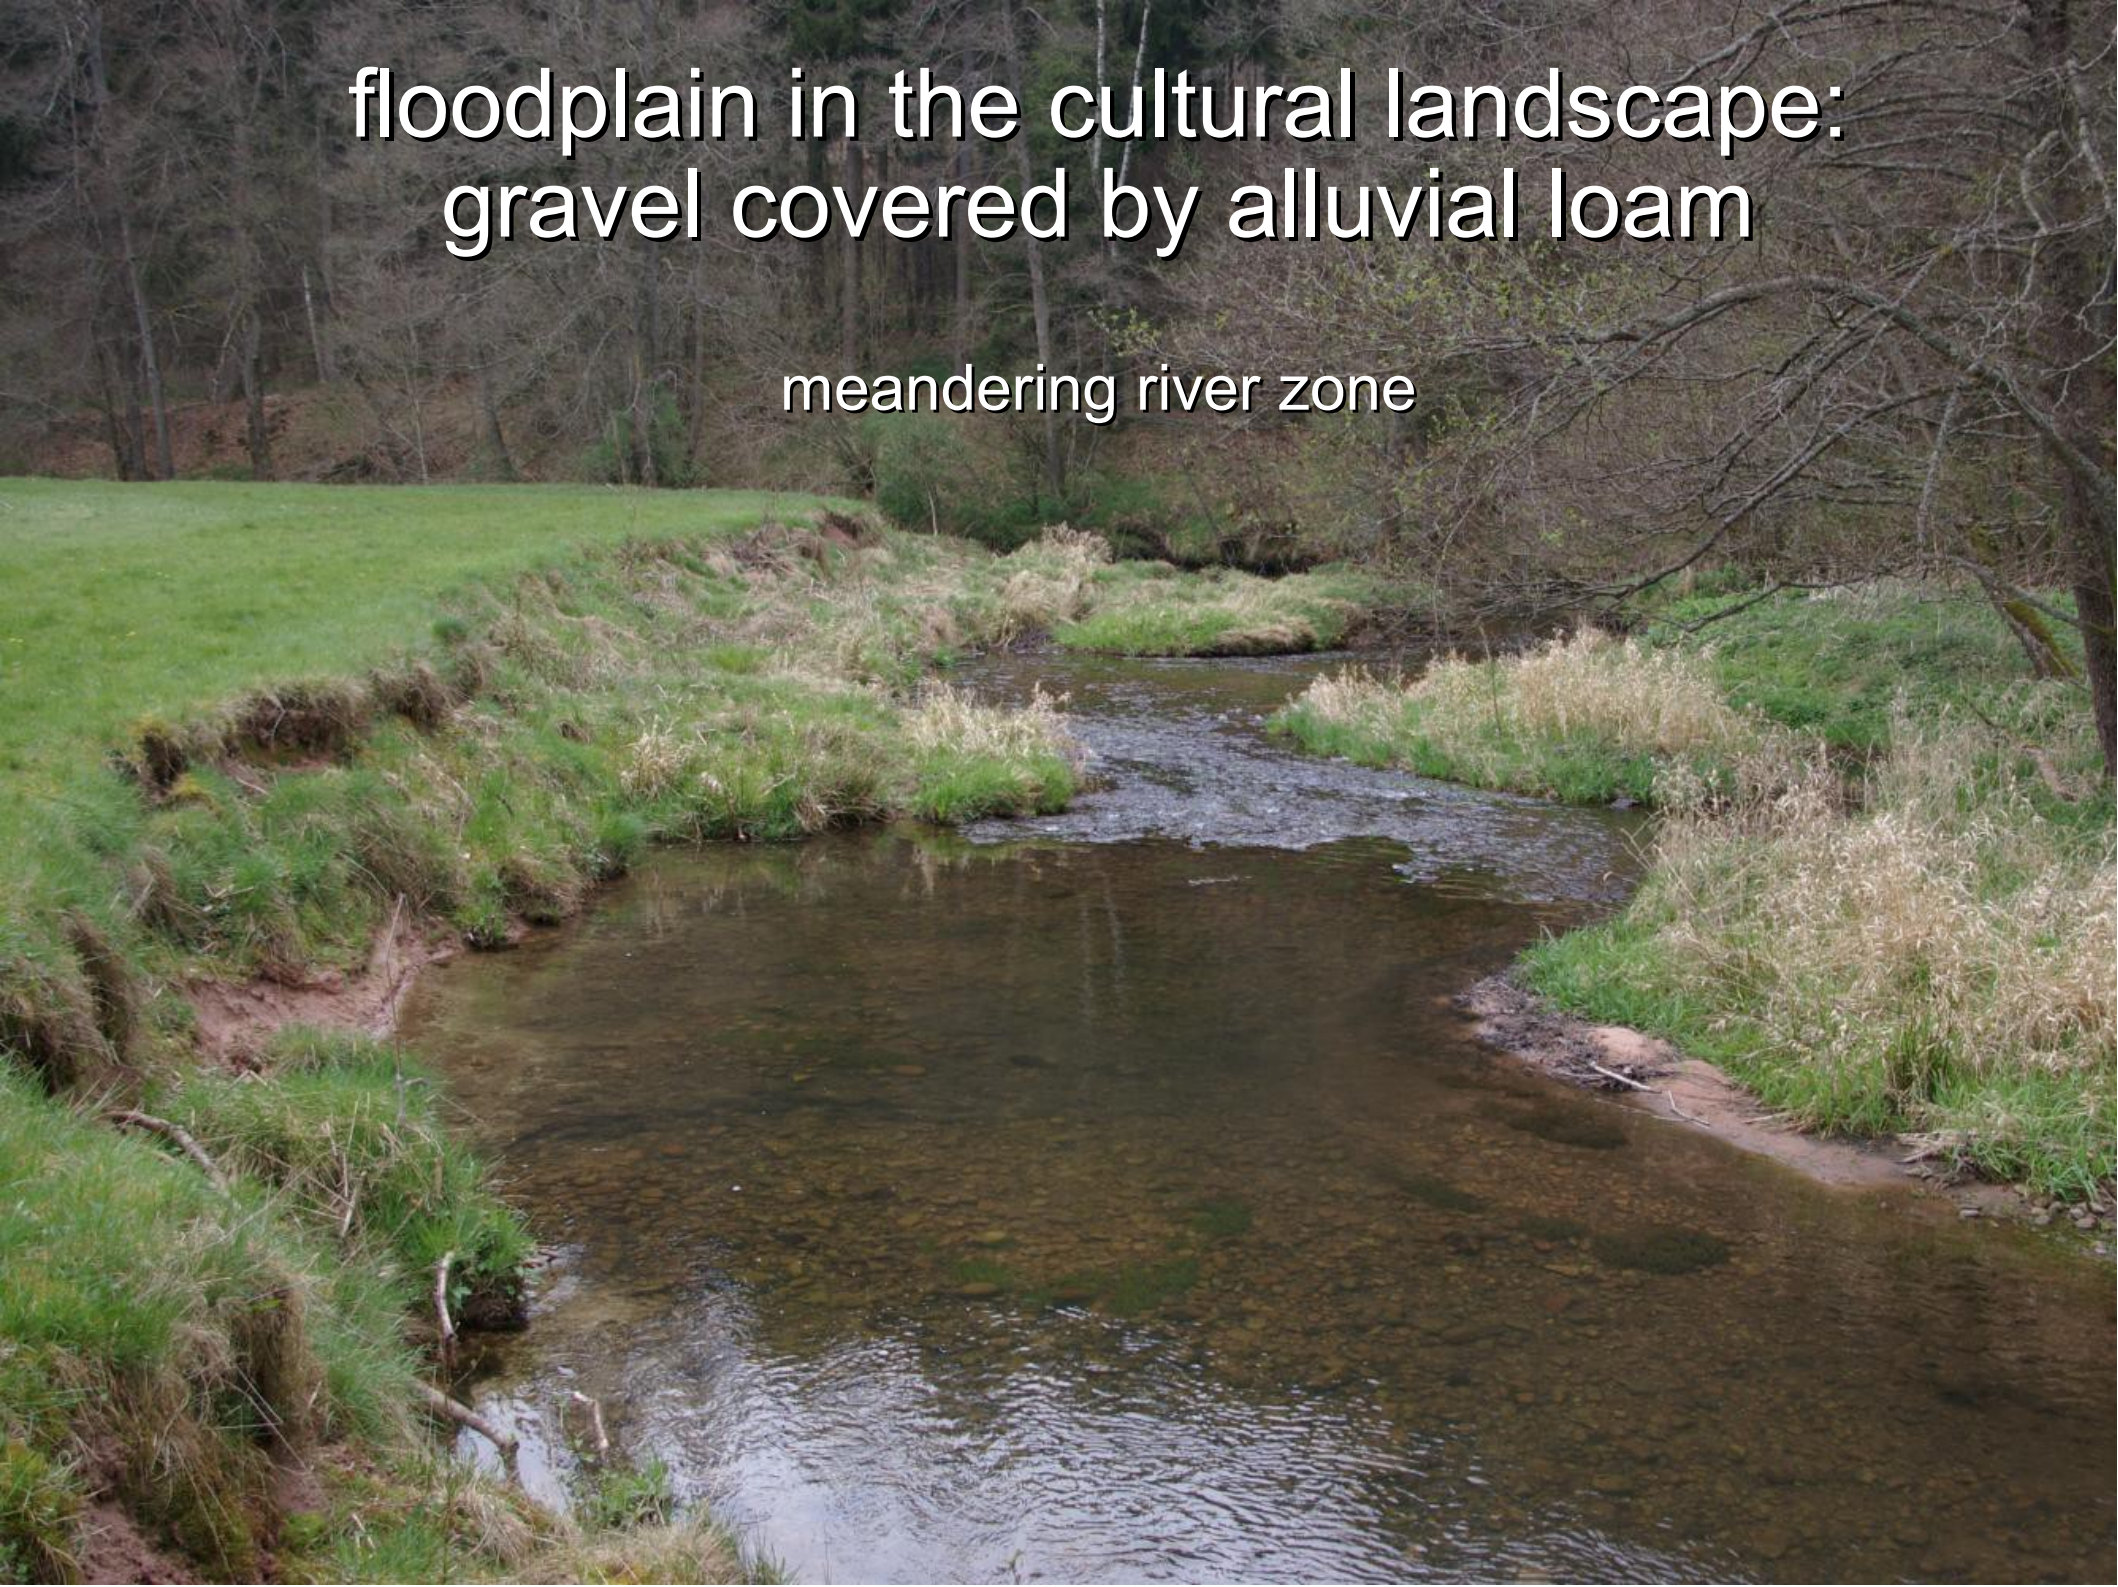
floodplain in the cultural landscape: gravel covered by alluvial loam

meandering river zone

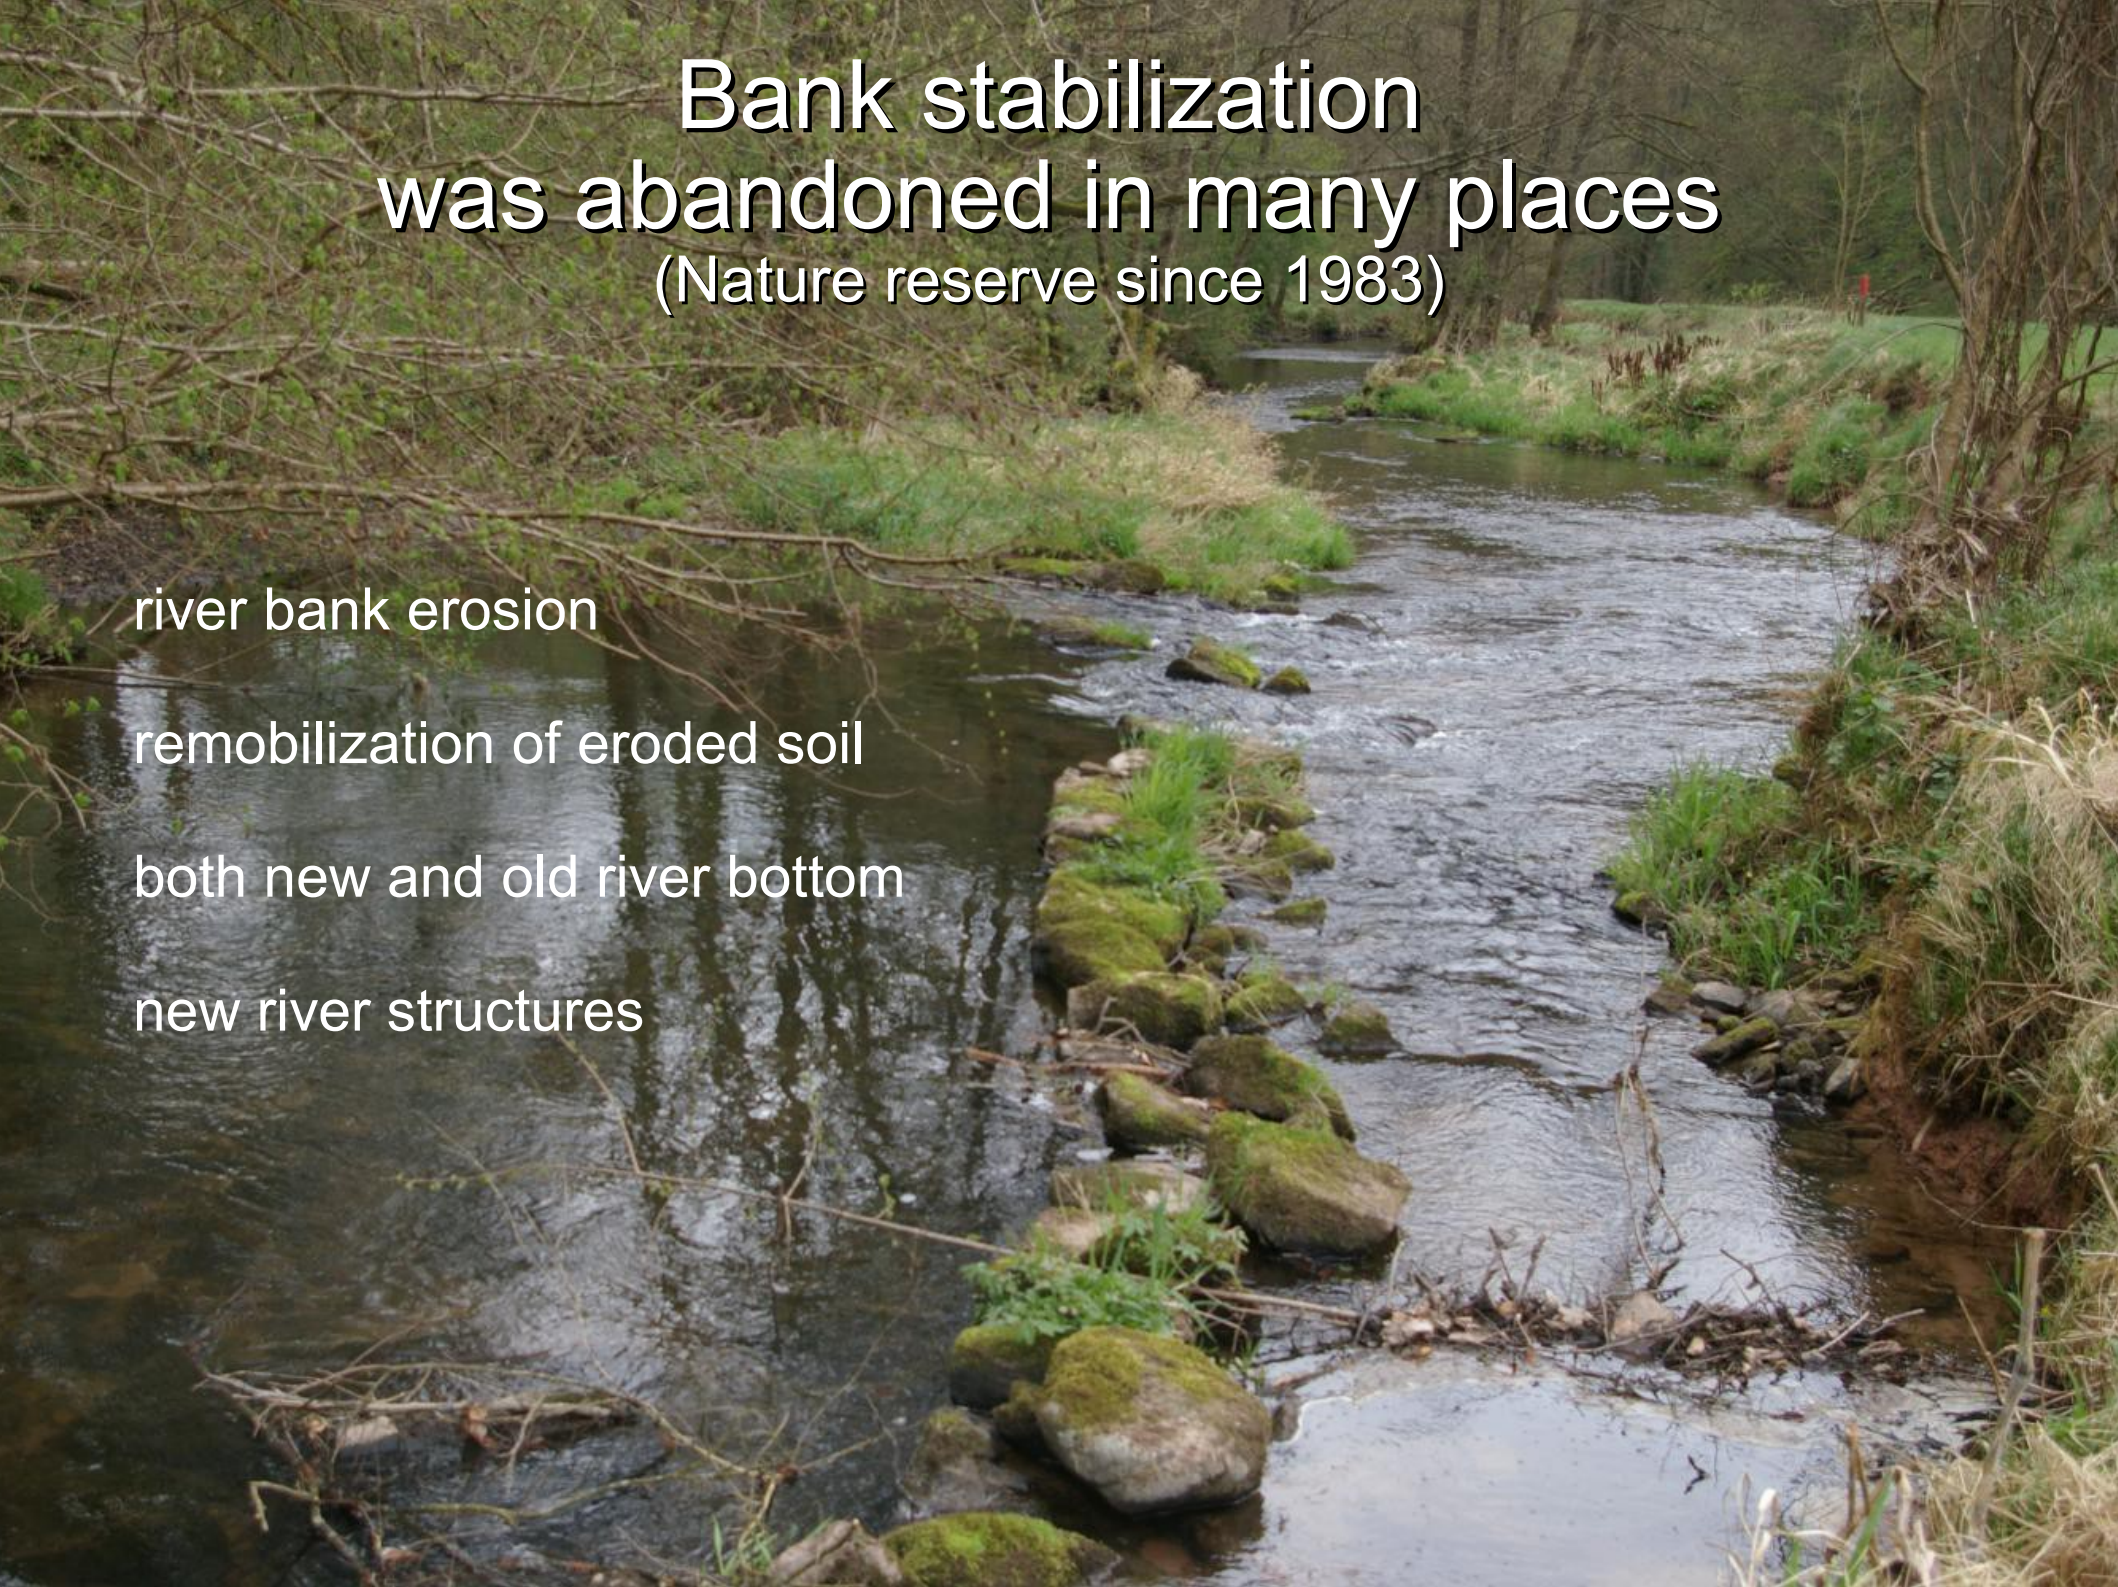
Bank stabilization was abandoned in many places (Nature reserve since 1983)

river bank erosion

remobilization of eroded soil

both new and old river bottom

new river structures

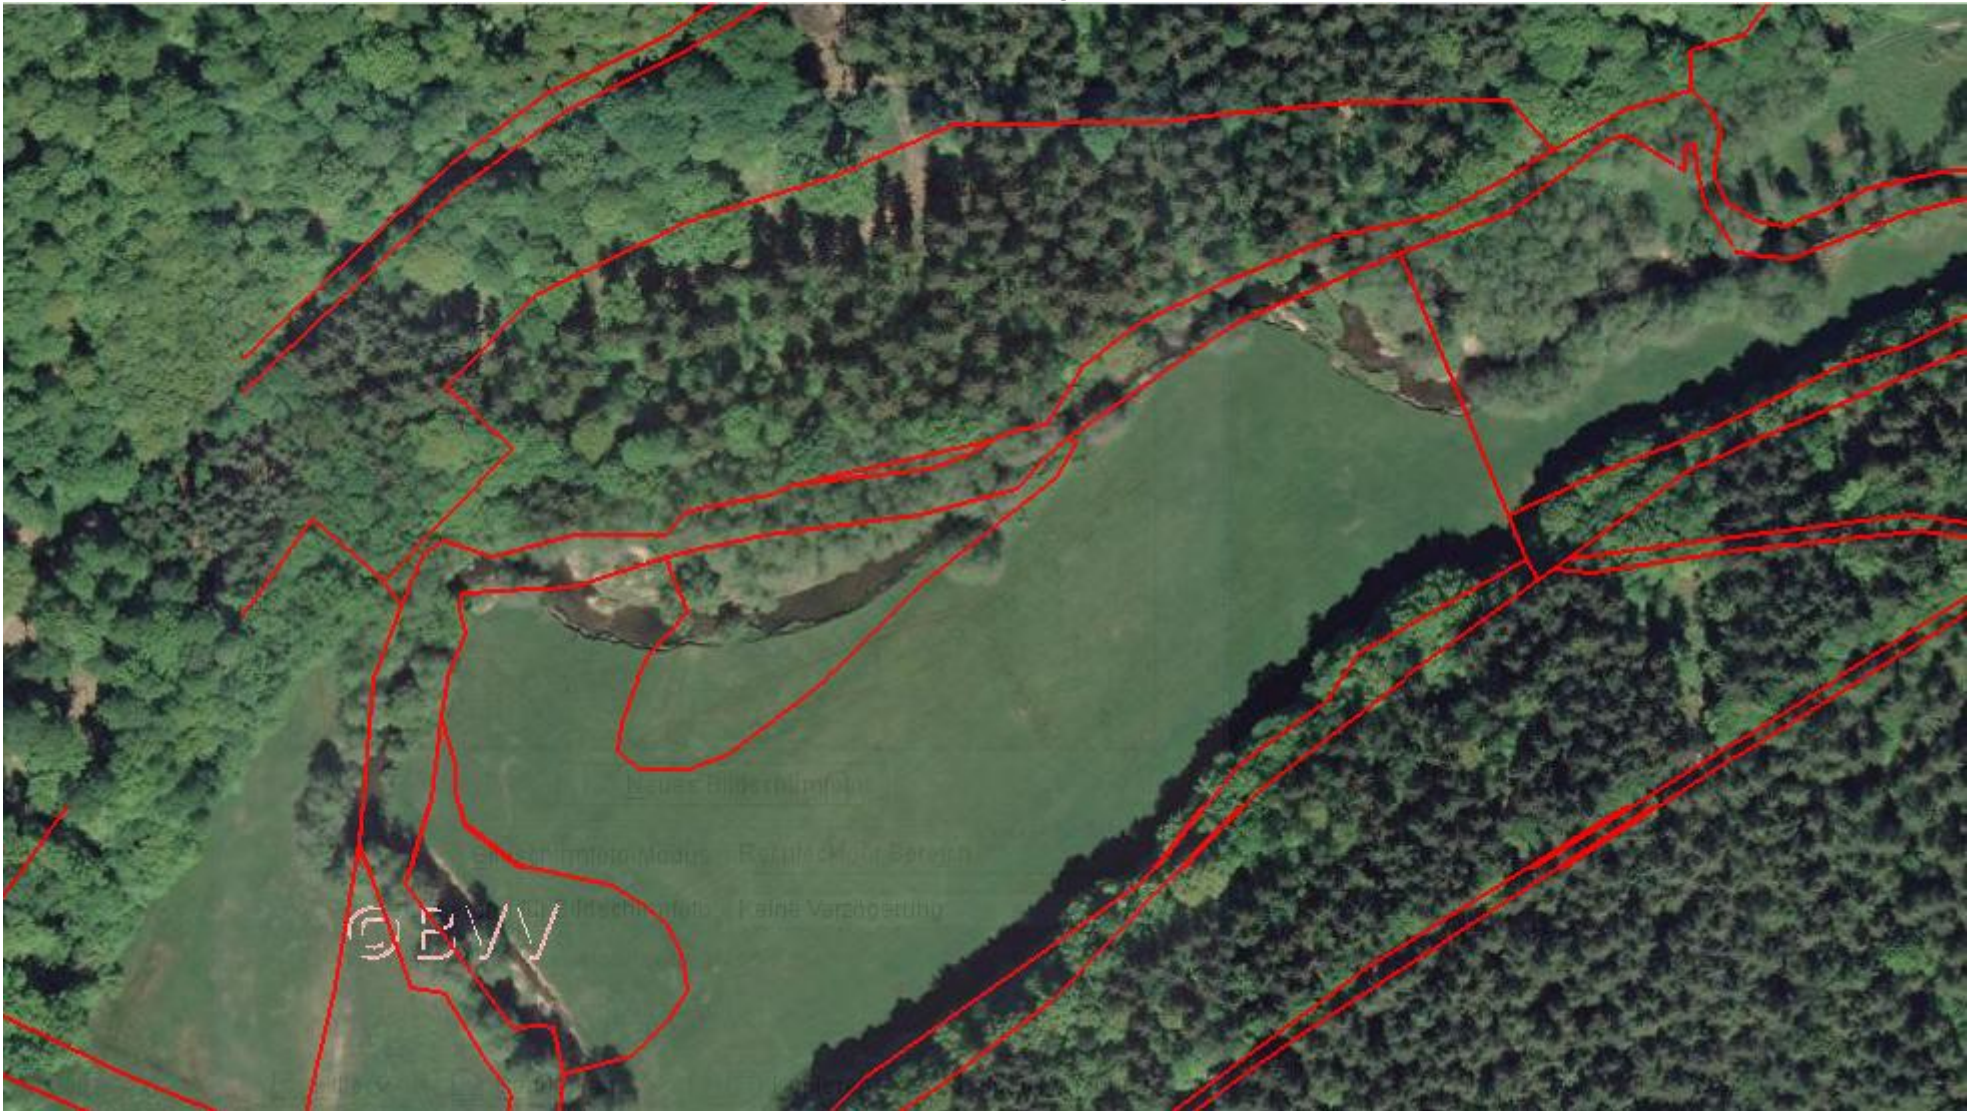
Schondra-floodplain today

long-term bank erosion and river dynamics

both meandering and braided stream stretches

very rich in river structures

near-natural state is approached

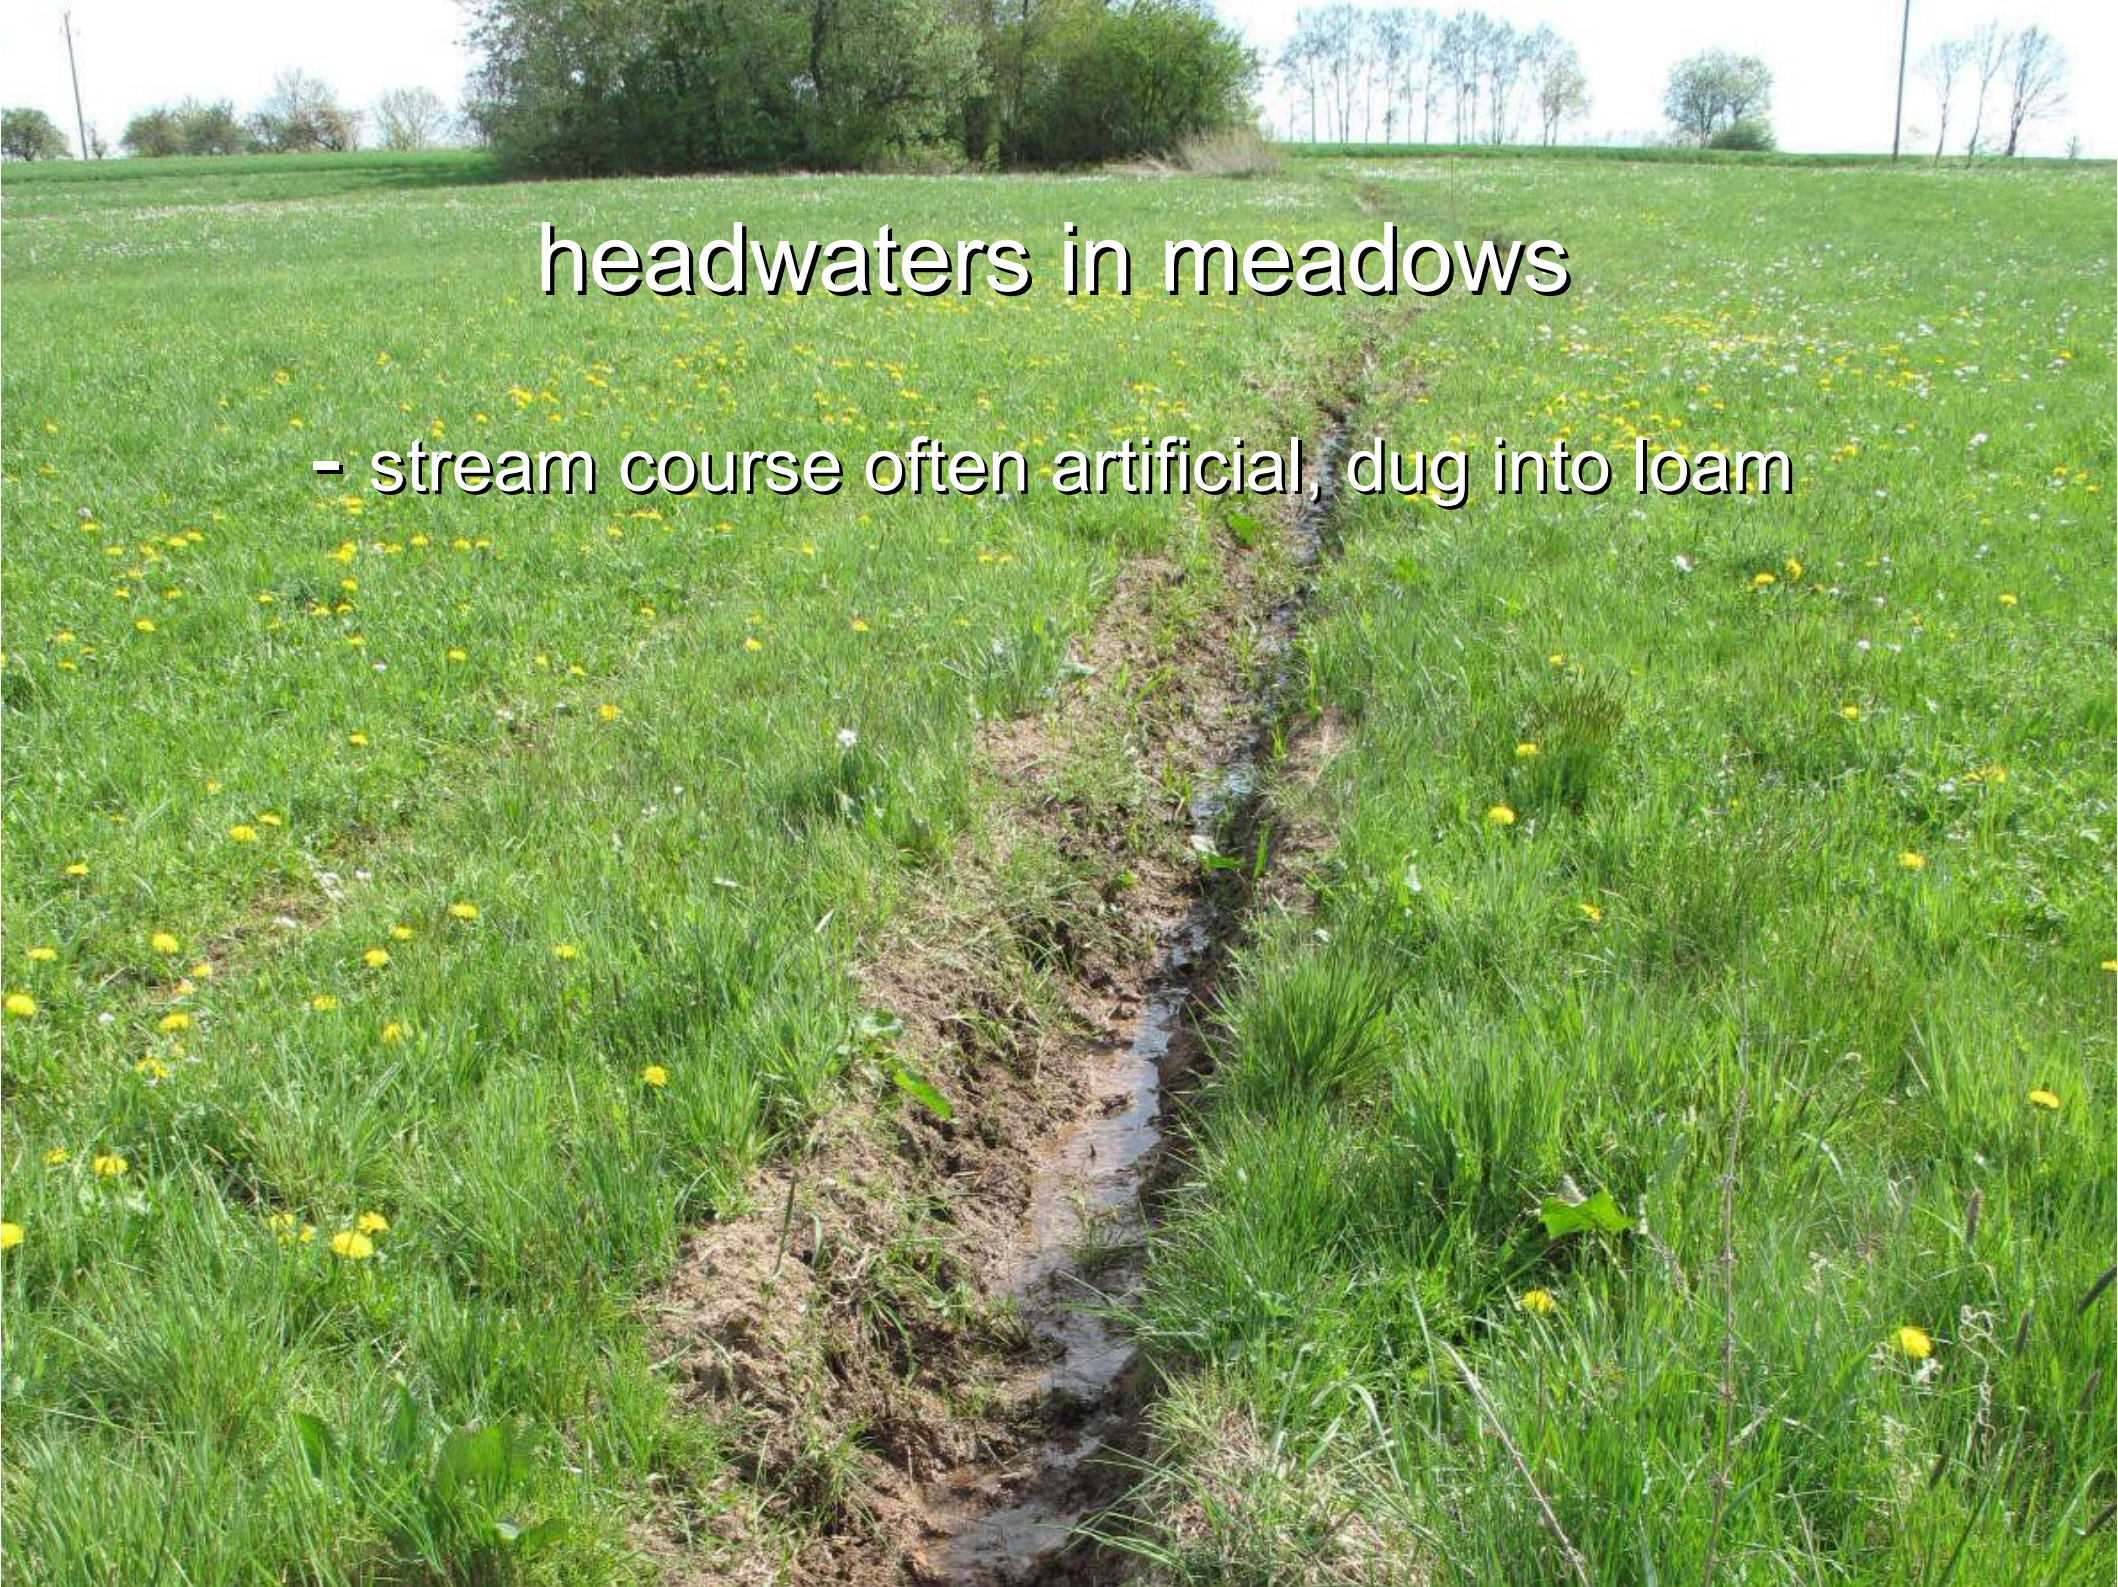
headwaters in meadows

- stream course often artificial, dug into loam

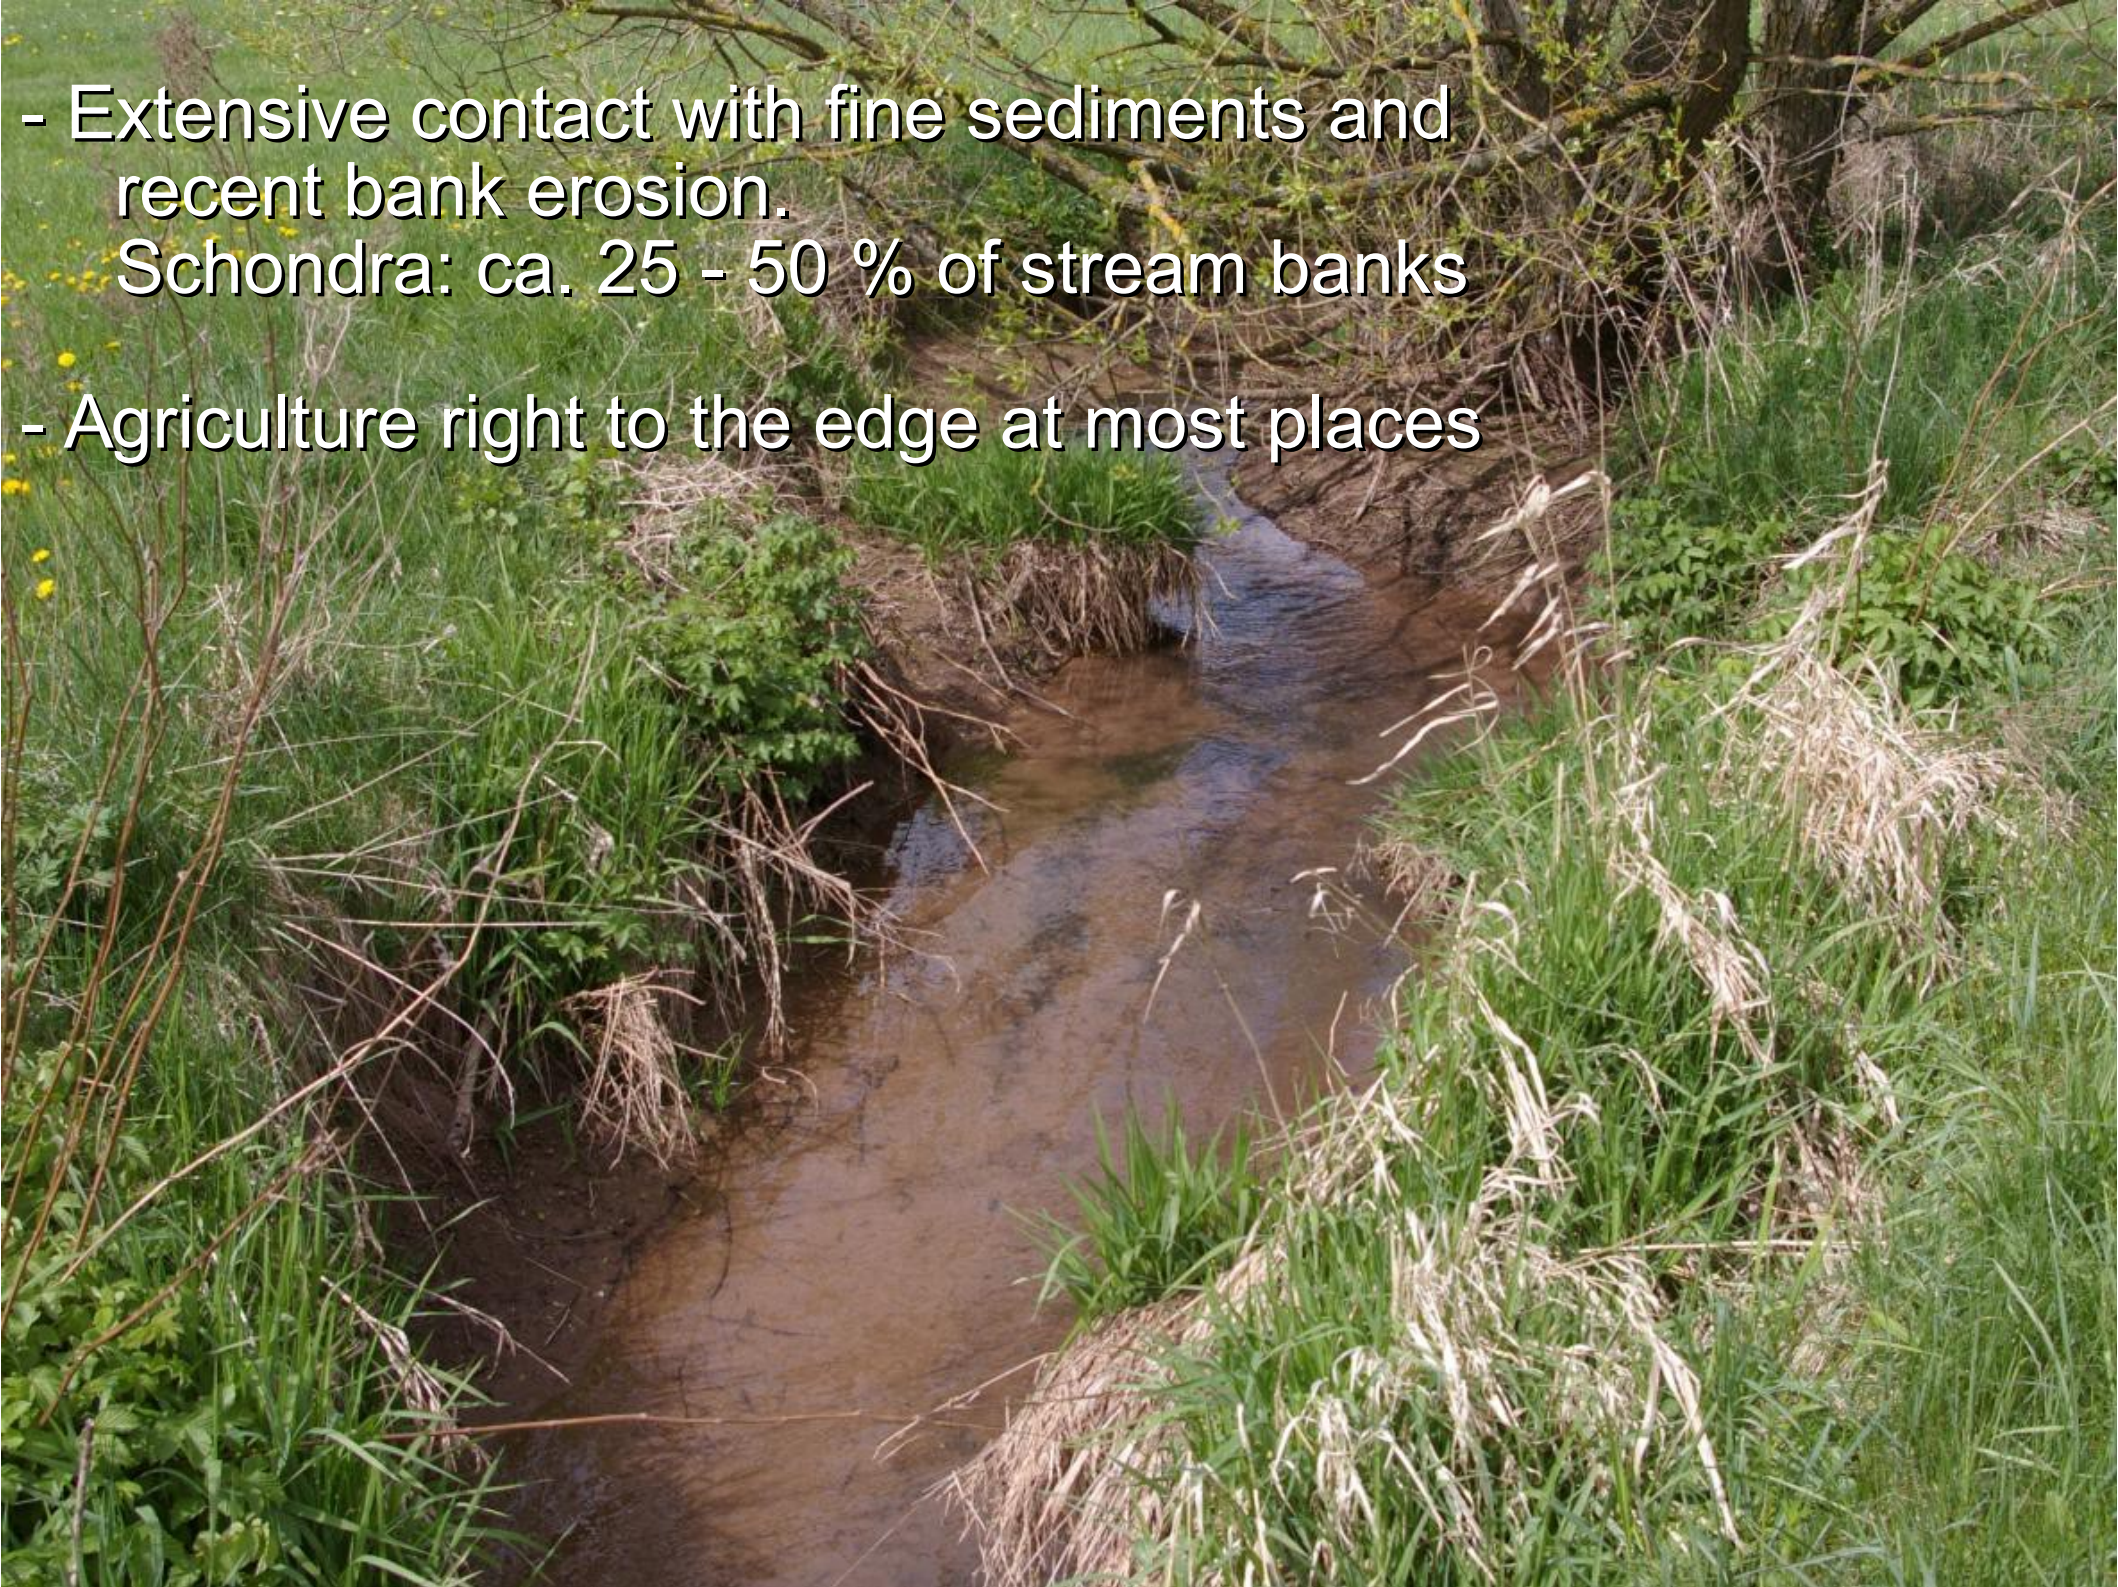
- Extensive contact with fine sediments and recent bank erosion.
Schondra: ca. 25 - 50 % of stream banks
- Agriculture right to the edge at most places
