River dynamics, bank erosion and the fine sediment load in pearl mussel rivers

Survey of bank erosion: Pearl mussel river Schondra, Rhine catchment

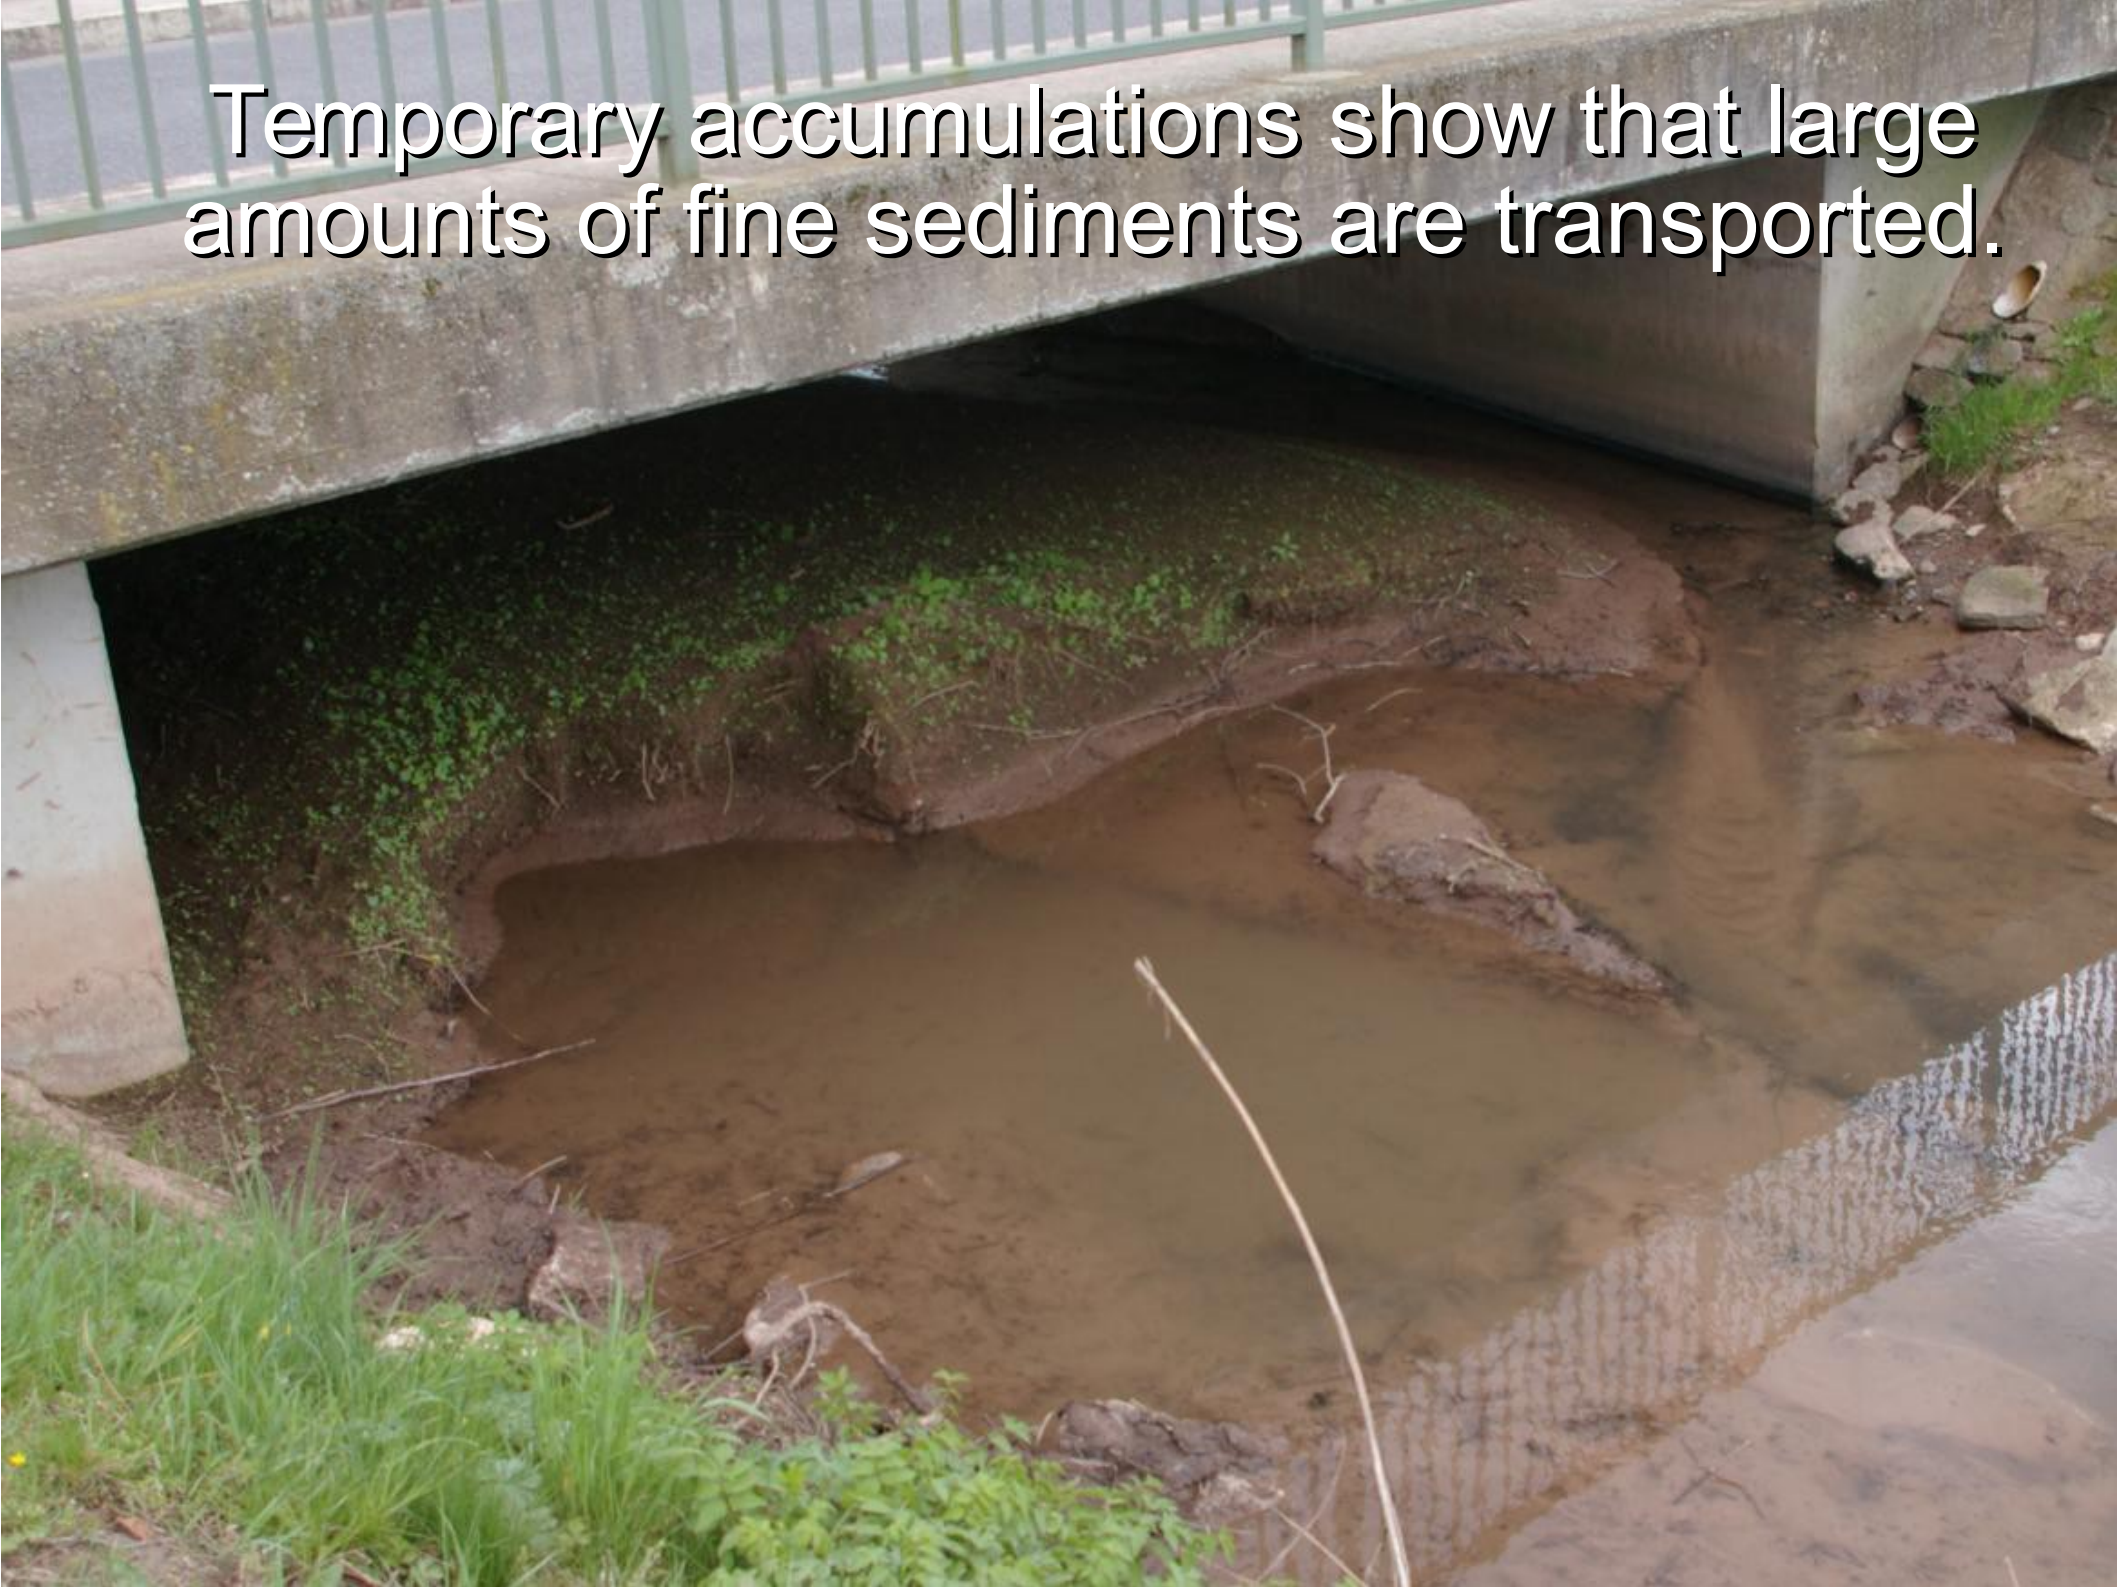
Temporary accumulations show that large amounts of fine sediments are transported.

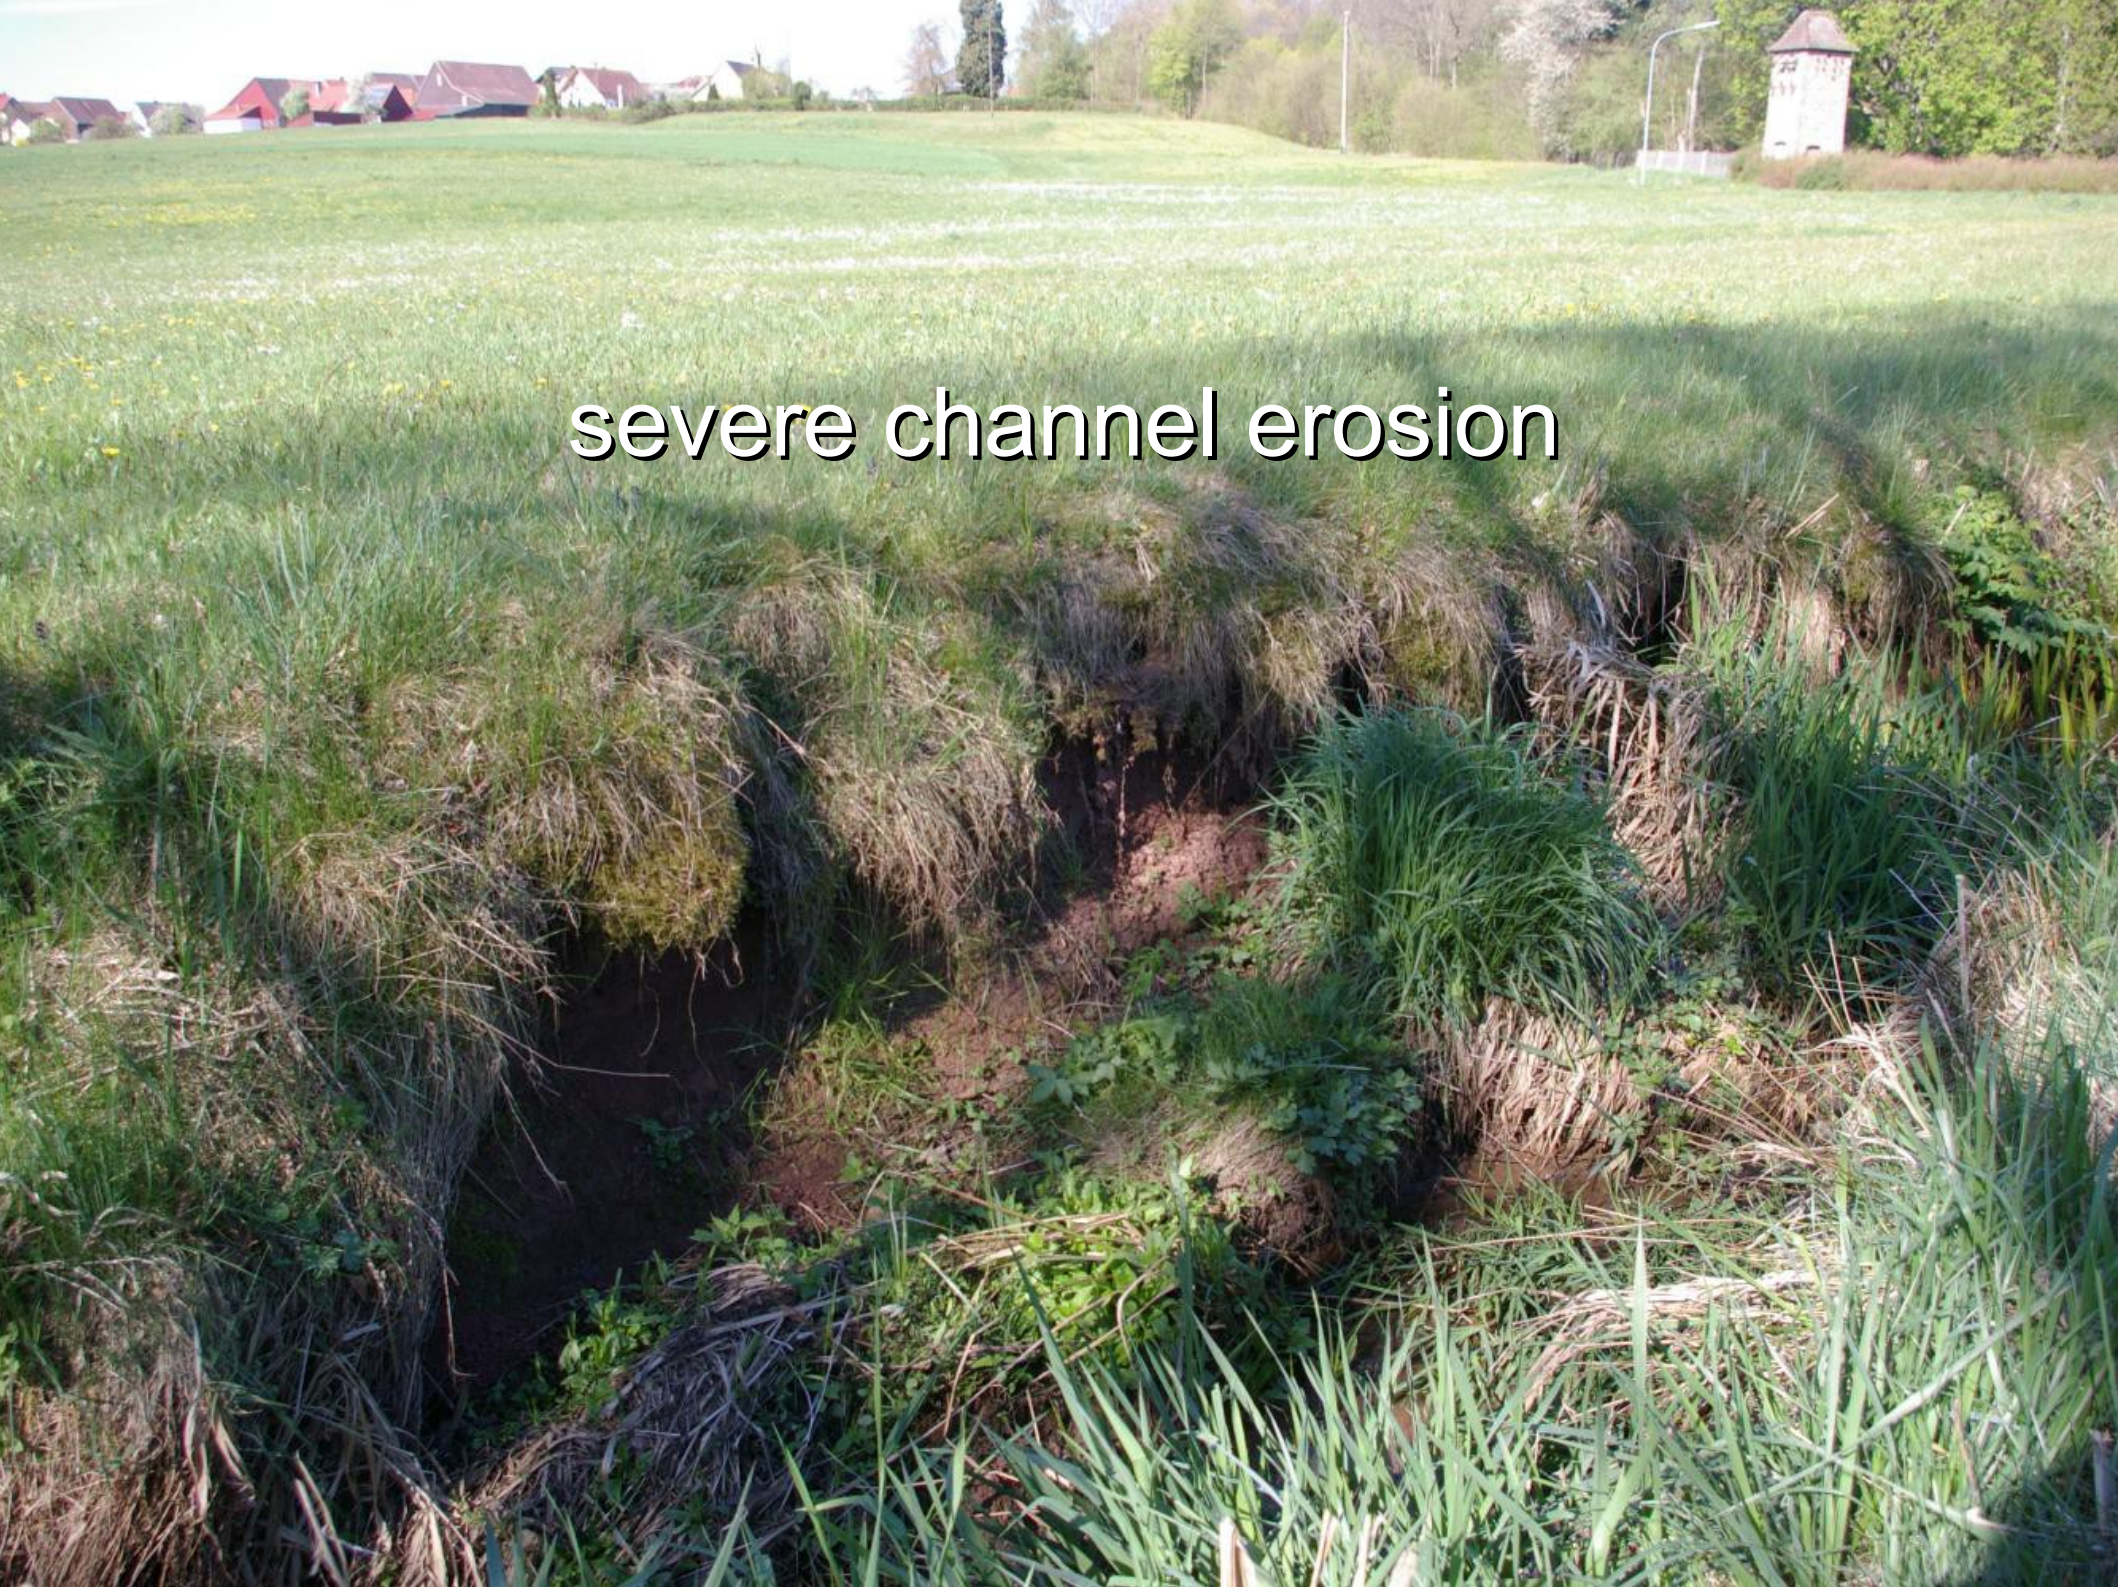
severe channel erosion

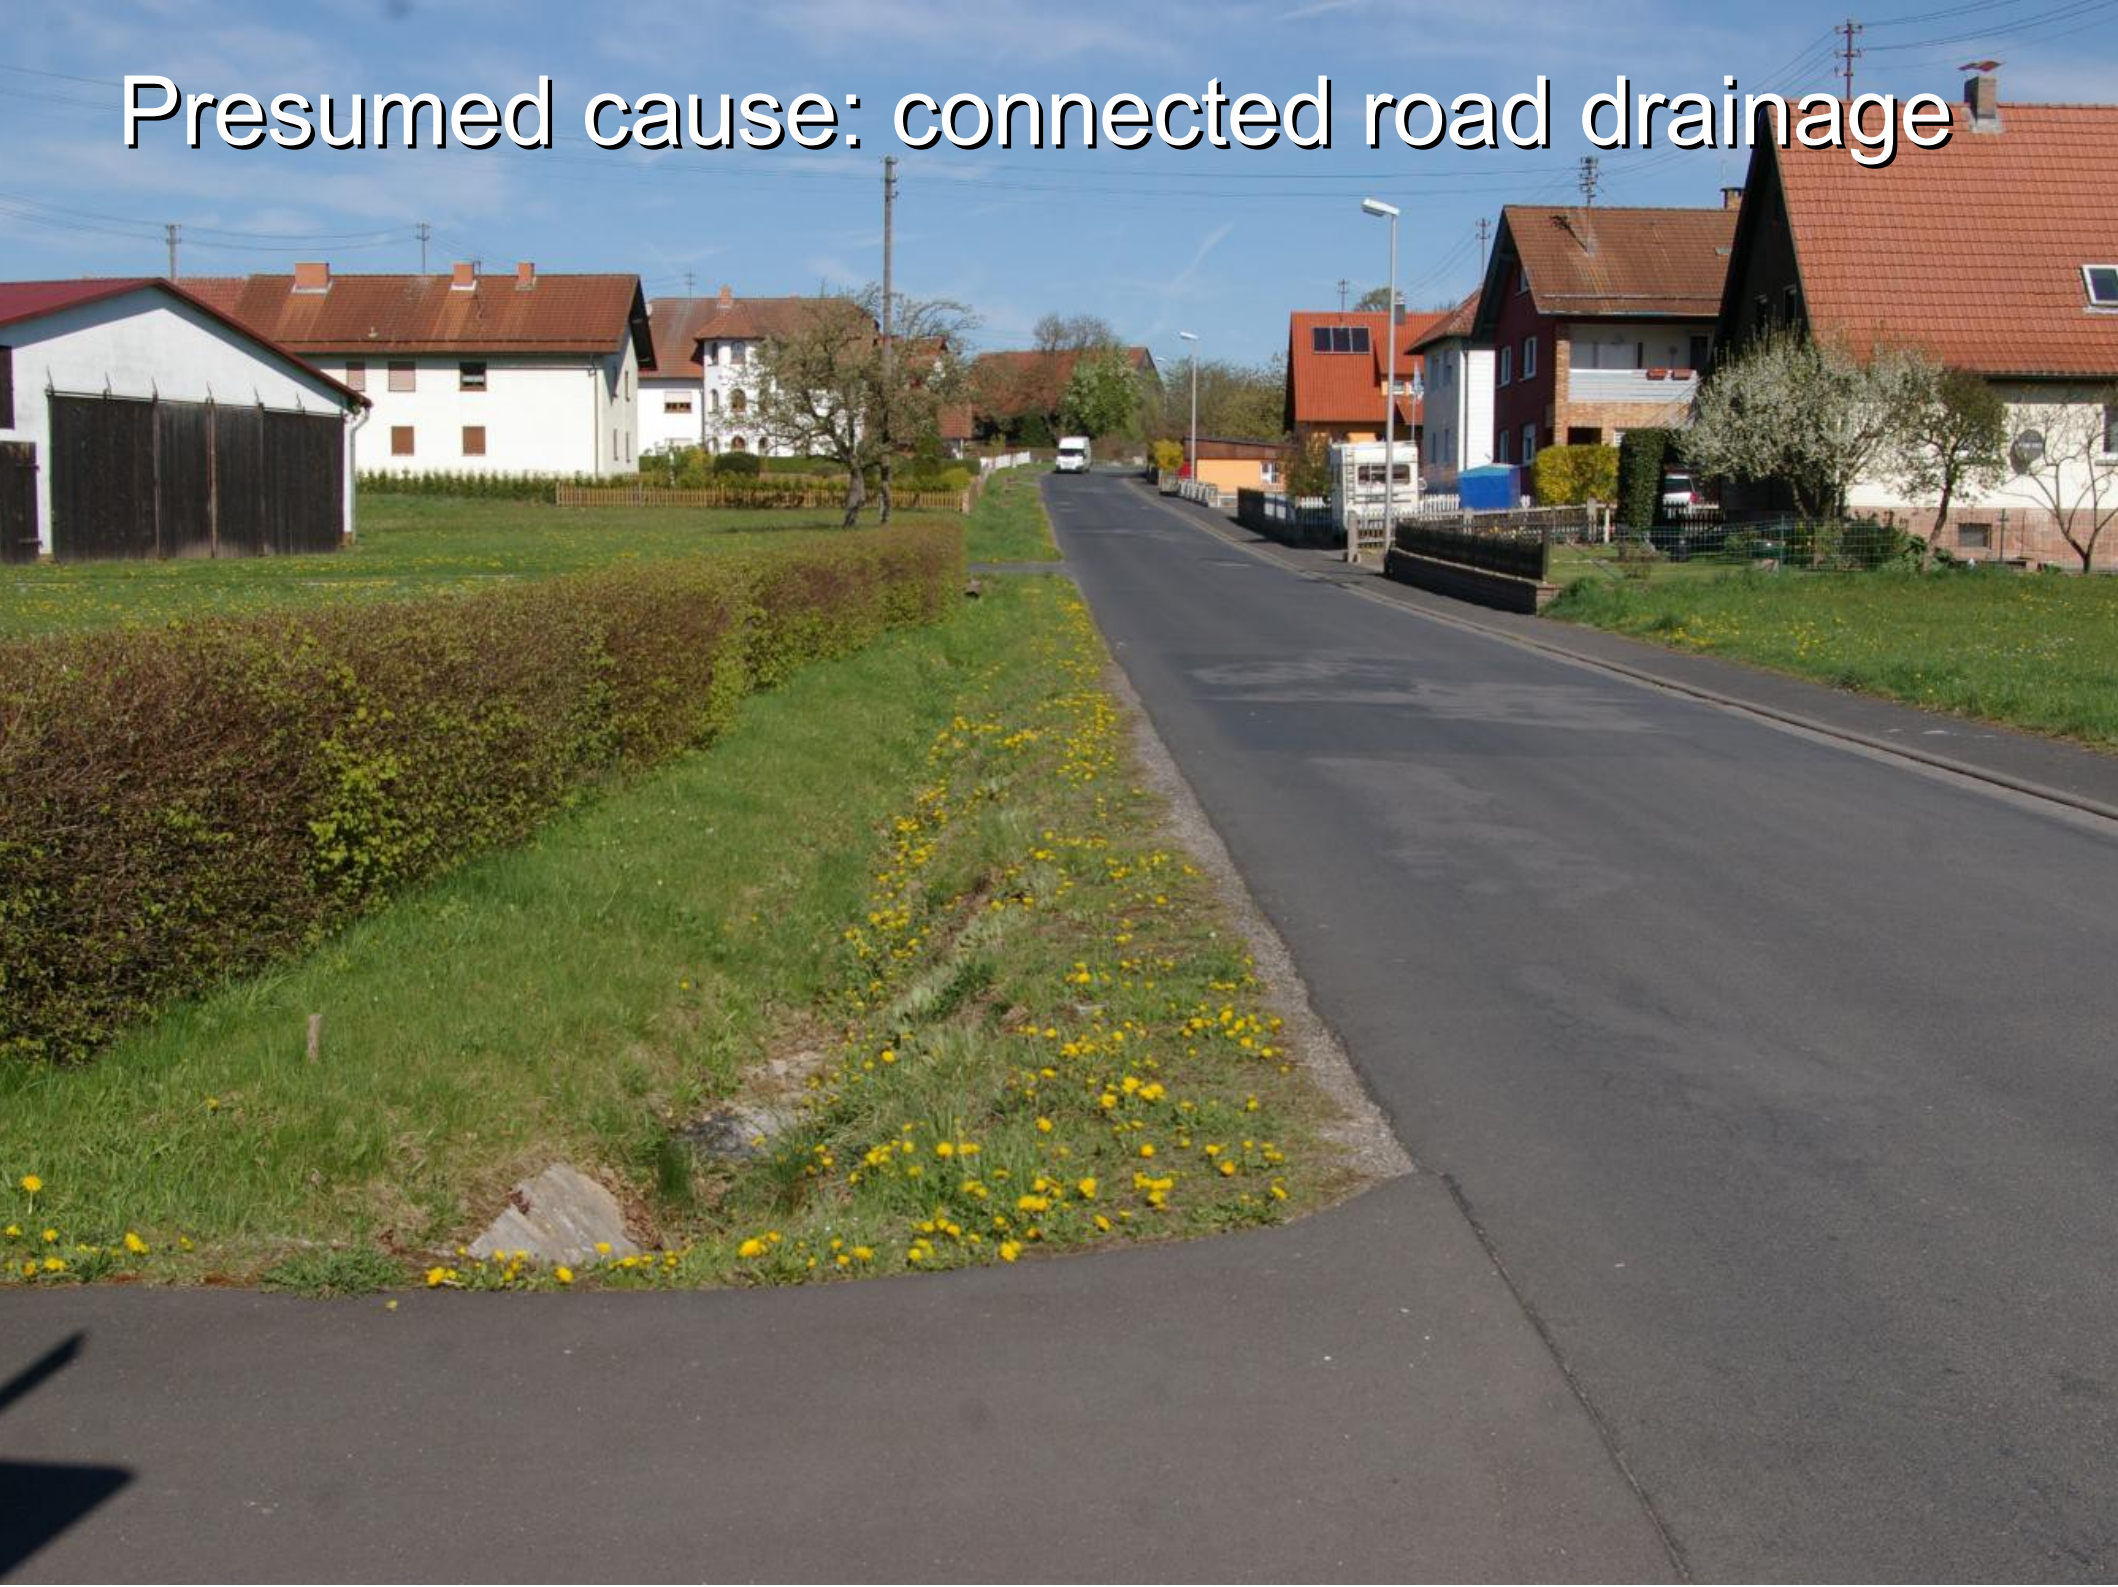
Presumed cause: connected road drainage

If surface runoff from sieled areas (e.g., roads) is connected, the channels tend to show severe channel erosion.
